**STATE OF HAWAII
DEPARTMENT OF LAND AND NATURAL RESOURCES
OFFICE OF CONSERVATION AND COASTAL LANDS
Honolulu, Hawaii**

REGARDING: Conservation District Enforcement File OA-07-31
Regarding Alleged Unauthorized Repair/Reconstruction of
a Boulder Revetment Within the Conservation District
Located at Mokuleia, Island of Oahu, TMK (1) 6-8-
003:018

SUBJECT: Repair of Shoreline Structure Dailey Residence, Mokuleia, Oahu (TMK: (1)
6-8-003:018).

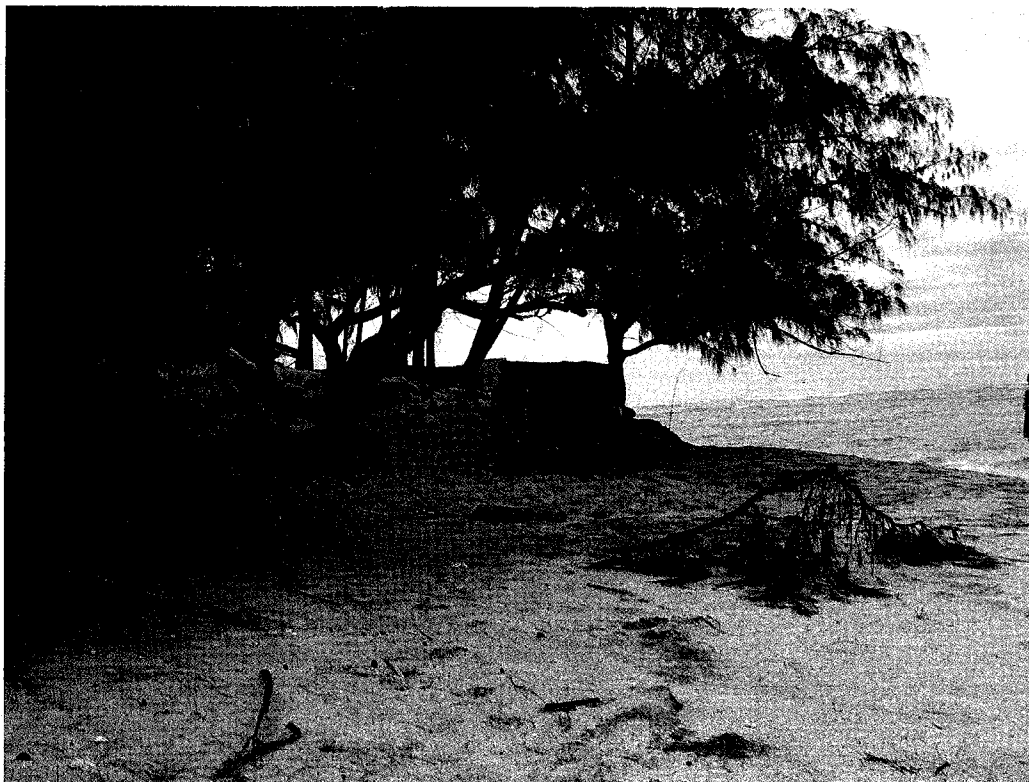
March 13, 2007 East of subject area

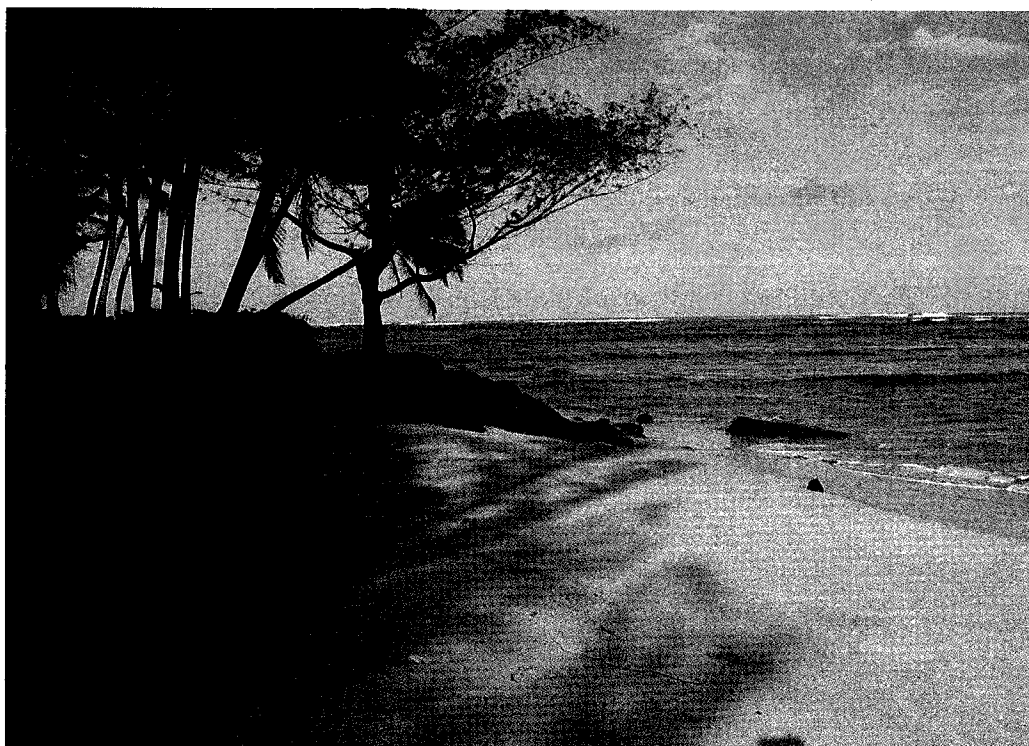
December 29, 2004 East of the subject area

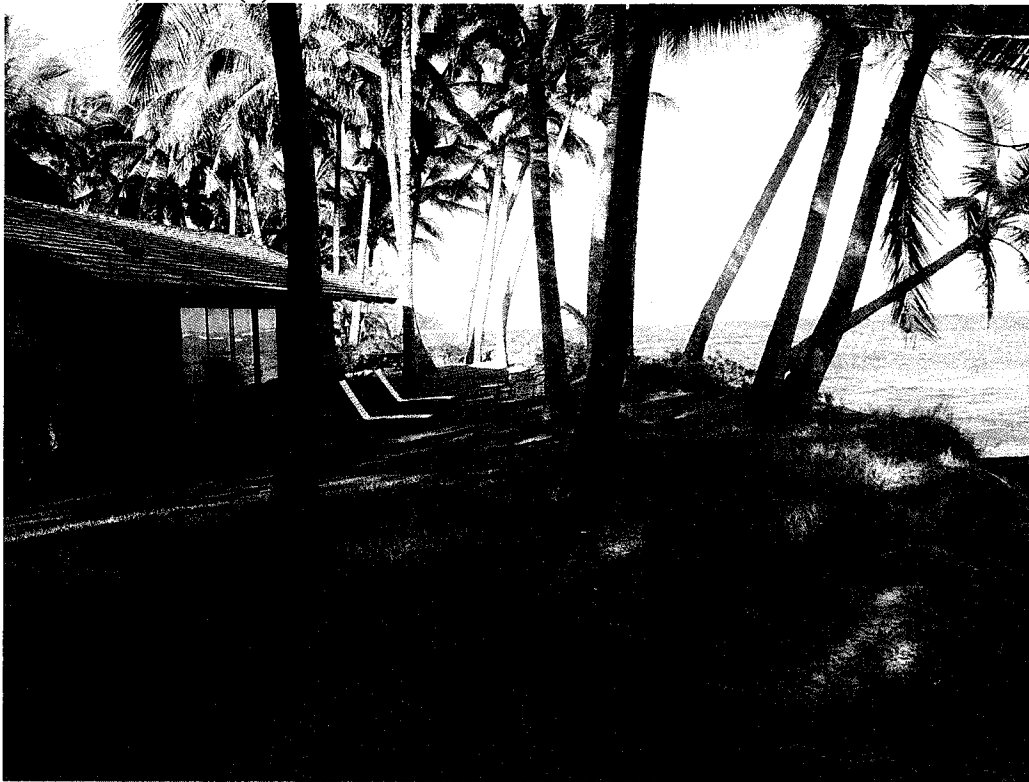
December 29, 2004-OCCL Staff conducted a site inspection of the subject area and noted that large portions of a revetment structure were scoured by the wave energy and the structural integrity of the revetment was compromised. Rocks had dislodged from the revetment and rolled down the structure and onto the beach. The large boulders appeared to be a safety hazard to the public. (**Exhibit 5**).

December 29, 2004

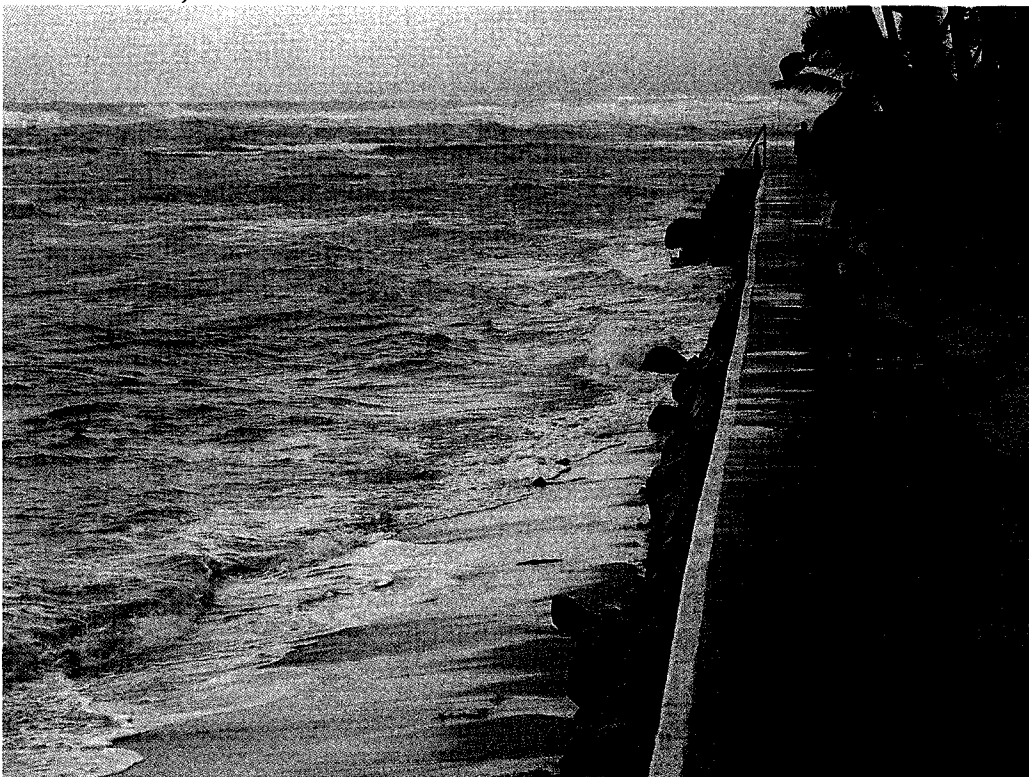
**December 29, 2006. Adjacent neighboring parcel to the West.
Wall is authorized via County BP 275154 dated September 20, 1989.**

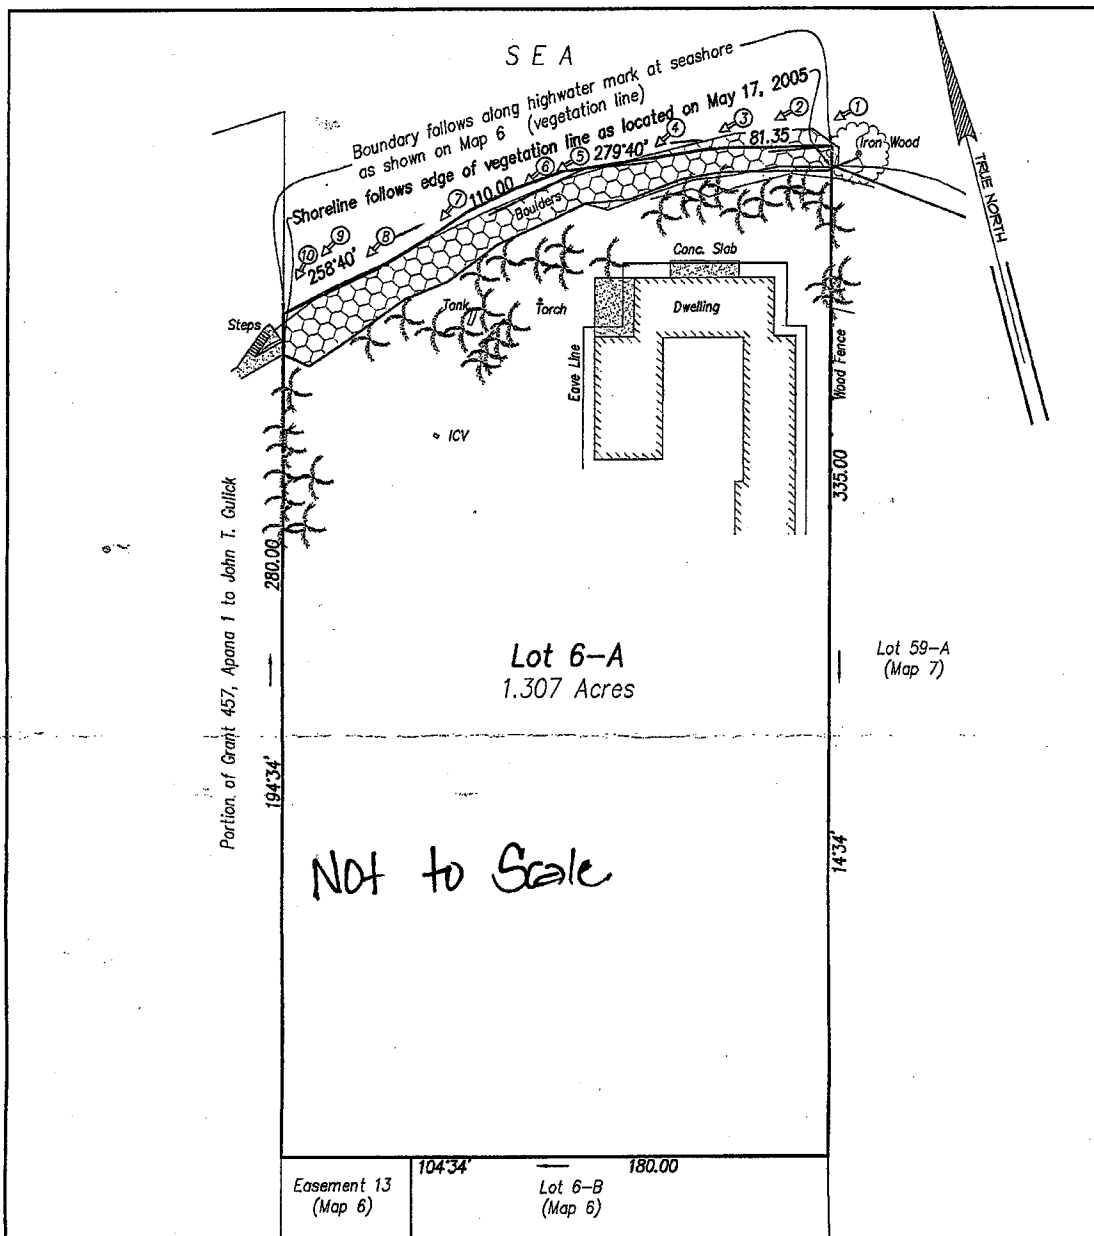
EXHIBIT 6

June 20, 2005-OCCL was in receipt of a survey of the subject property that illustrated the proposed location of the current shoreline with respect to the revetment (**Exhibit 6**). It appeared a portion of the revetment encroached onto State land. Correspondence dated June 27, 2005, from OCCL to the landowner's counsel encouraged them to take action to reduce or eliminate the hazard of the loose rocks from the failed revetment prior to the onset of the winter surf.

Shoreline Survey
Lot 6-B (Map 6)
of Land Court Application 1810
at Mokuleia, Waialua, Oahu, Hawaii
Tax Map Key: 6-8-03: 18 (1st Division)

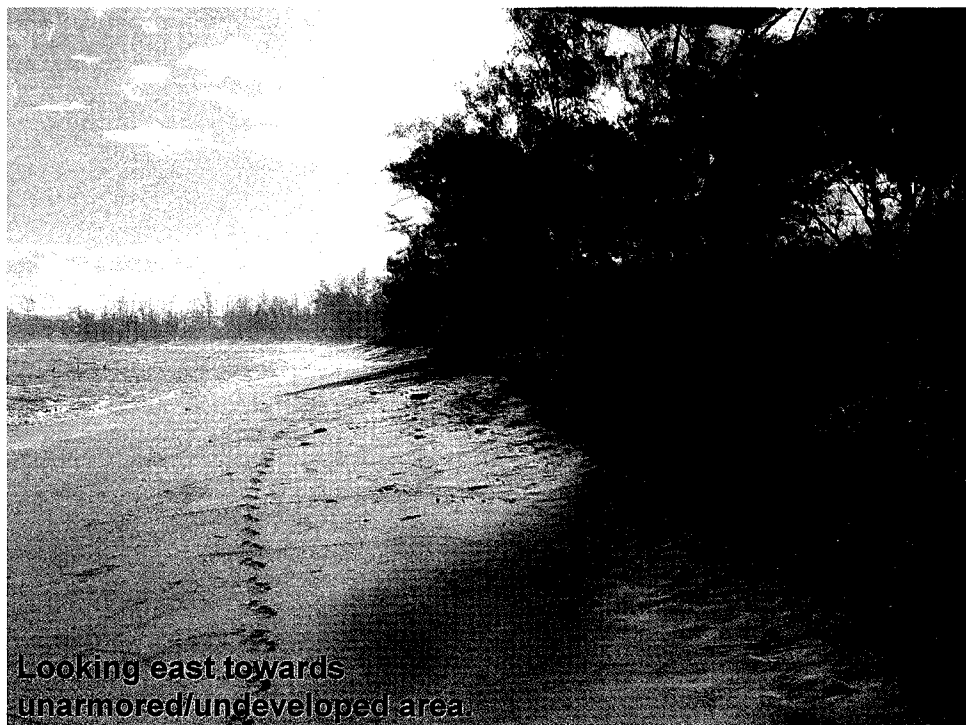
Figure 1. Eastern portion of subject structure.
Note the landward shift on the beach profile at the end of the structure.

4. The OCCL finds that the revetment may be beyond repair based on the fact that the revetment is completely failing and does not appear that appropriate engineering considerations were made during the construction. Long-term repair work to the revetment should be considered *reconstruction* and would involve complete removal of the rocks to build an appropriate filter layer and foundation underneath the top layer of rocks.

- a. Replace the existing structure with a new engineered revetment located as far mauka as possible (entirely landward of the shoreline) and designed to enhance public access along the structure with a public easement along a clear walkway. Ideally this would be conducted in conjunction with relocation of the dwelling landward to allow for more accommodation space for the beach. Moving the dwelling landward provides for more design alternatives for new structures as well.

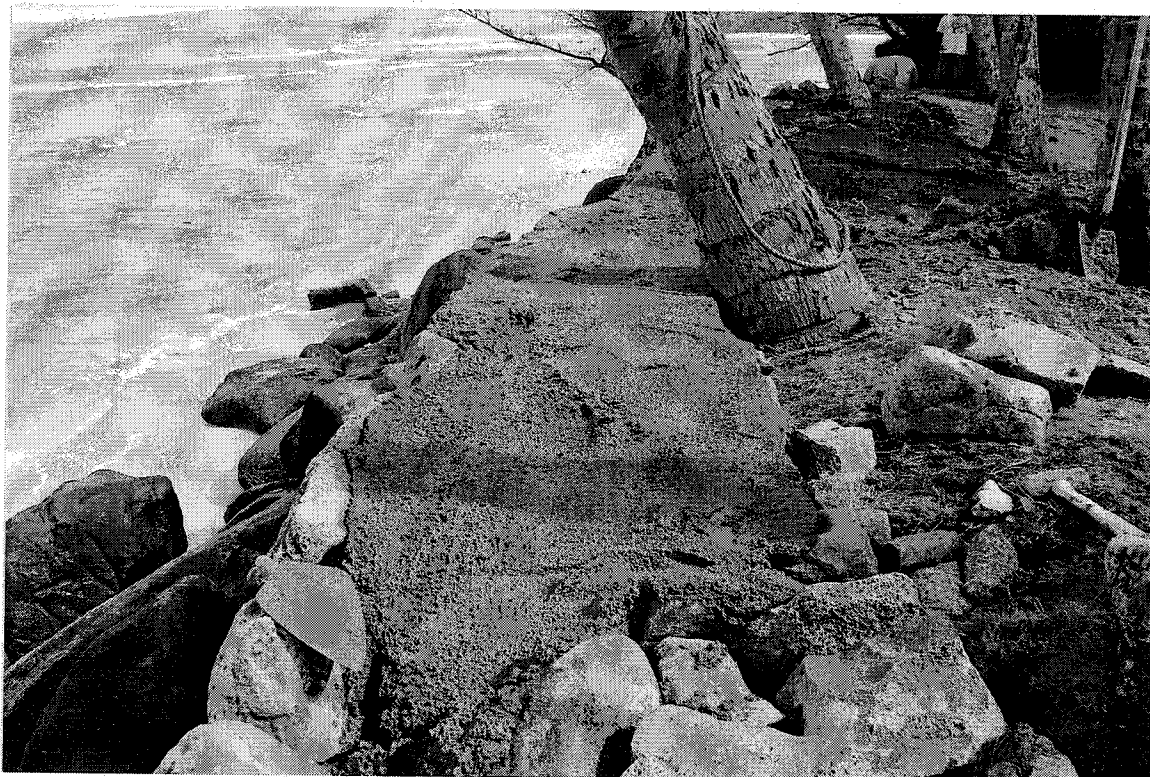
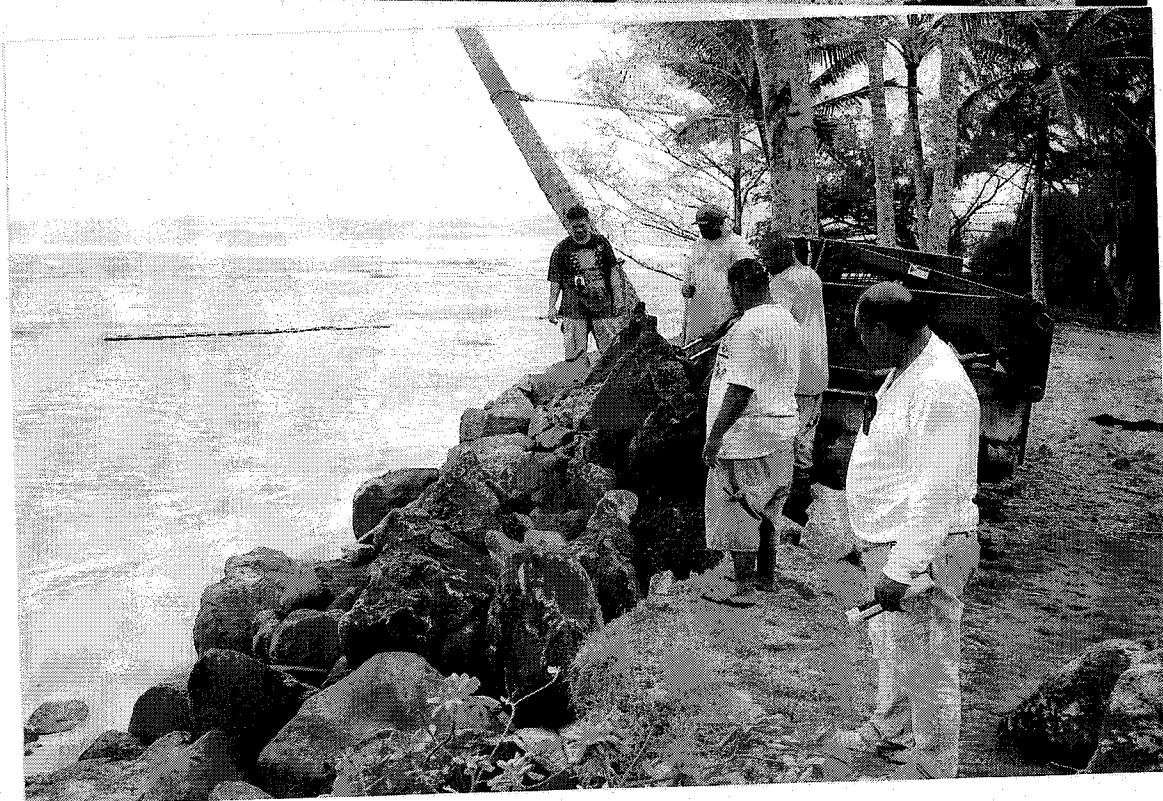
EXHIBIT 10

December 23, 2006- NOTICE and ORDER hand delivered to Michael Dailey by a Conservation Enforcement Officer. Photographs taken illustrate the active construction and placement of rocks as part of a repair/replacement effort. Staff notes the use of sandbags and soil for backfill and the pouring of what appears to be cement over boulders and rocks for what appears to be a seawall on top of the unstable unauthorized revetment (**Exhibit 9, 10 & 11**).

Unauthorized Shoreline Structure-Mokuleia, Oahu TMK: (1) 6-8-003:018

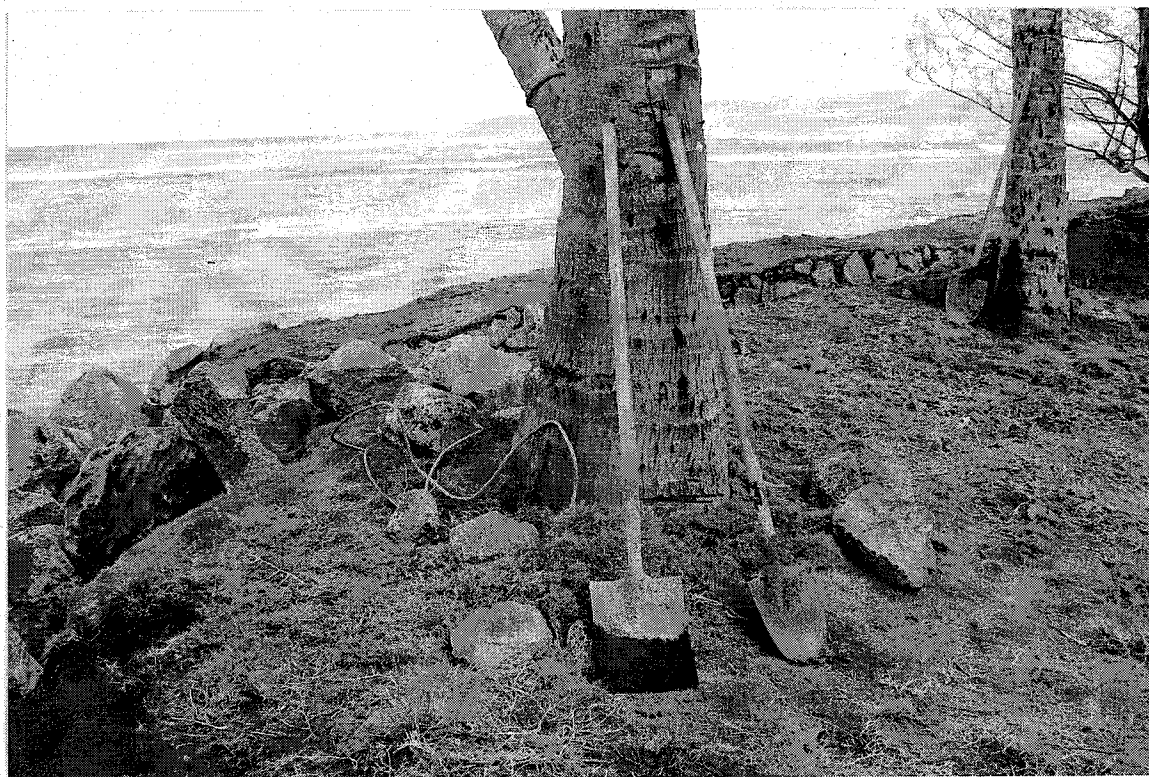
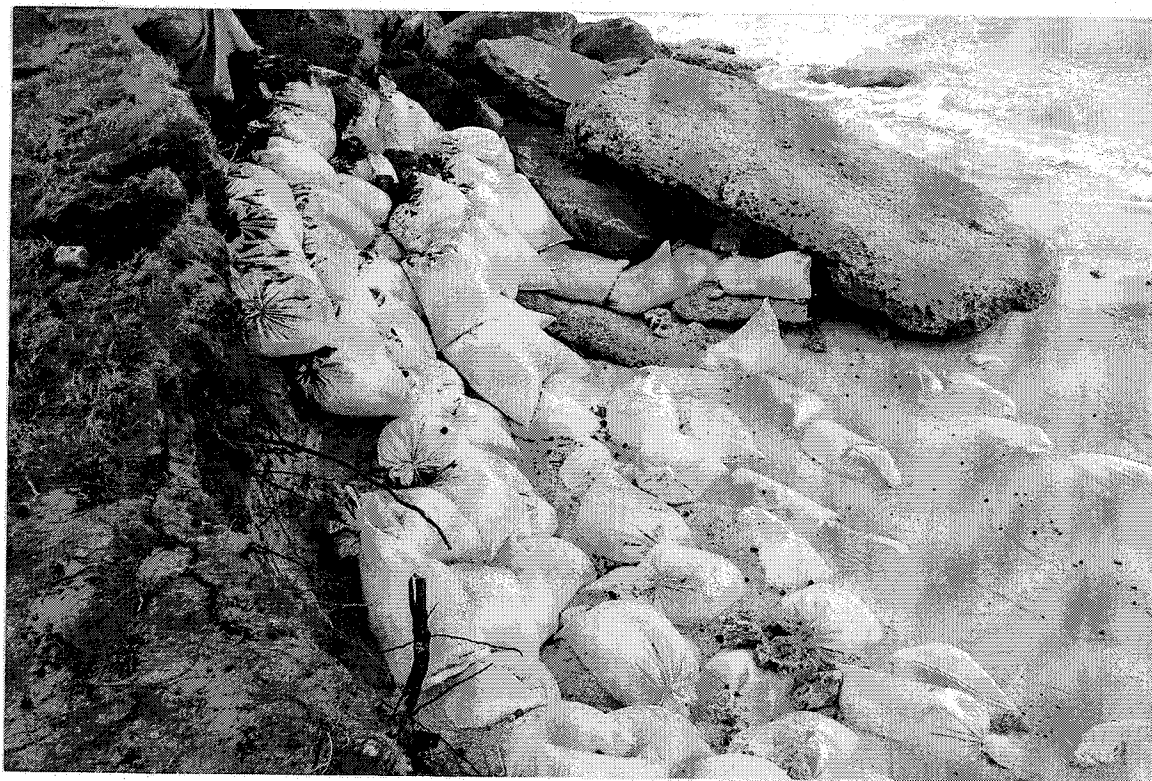
EXHIBIT 11

Unauthorized Shoreline Structure-Mokuleia, Oahu TMK: (1) 6-8-003:018

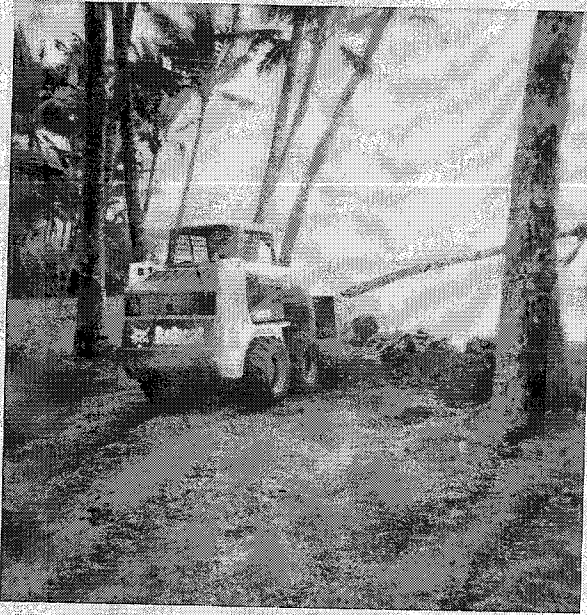
December 28, 2006- Site inspection by a Conservation Enforcement Officer noted active work being conducted within the shoreline on top of the previously existing shoreline structure. Conversation with the workers indicated that the Notice and Order to cease construction was known as an individual stated that the owner told them that he was being fined anyway, so to go ahead with construction. (**Exhibit 12**)

Depicts Bobcat used in construction
of wall

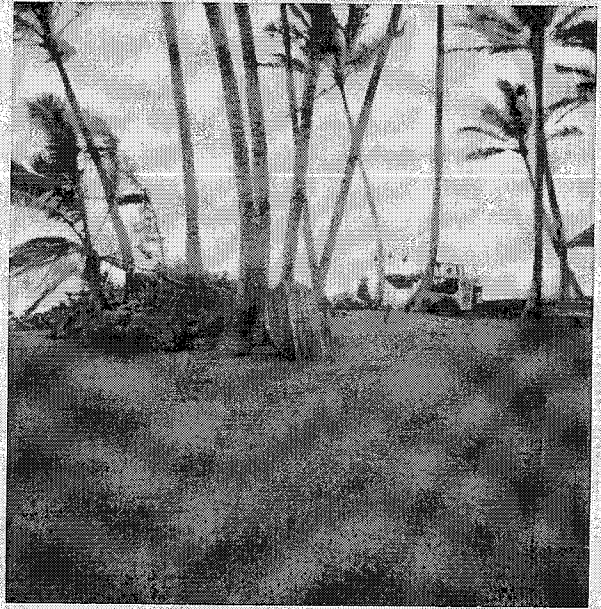
Depicts workers unloading cement
onto wall

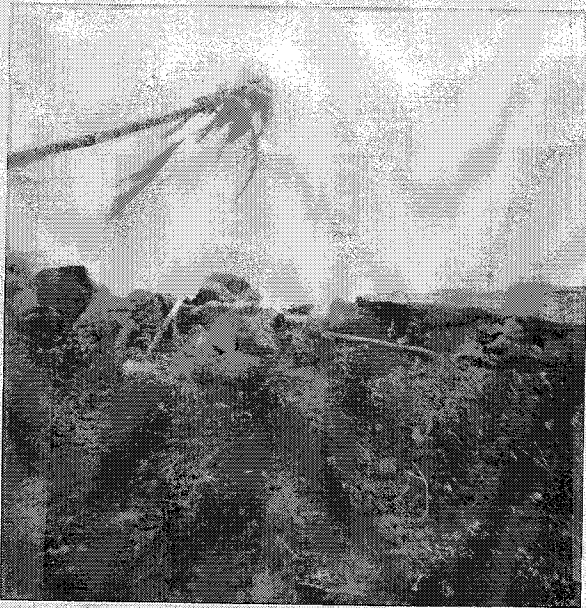
December 29, 2006- Site inspection by OCCL Staff noted active work being conducted within the shoreline on the unauthorized shoreline structures. Conversation with the workers indicated that it was known that the continued work was subject to daily fines (**Exhibit 13**).

Depicts tools used for construction
on wall

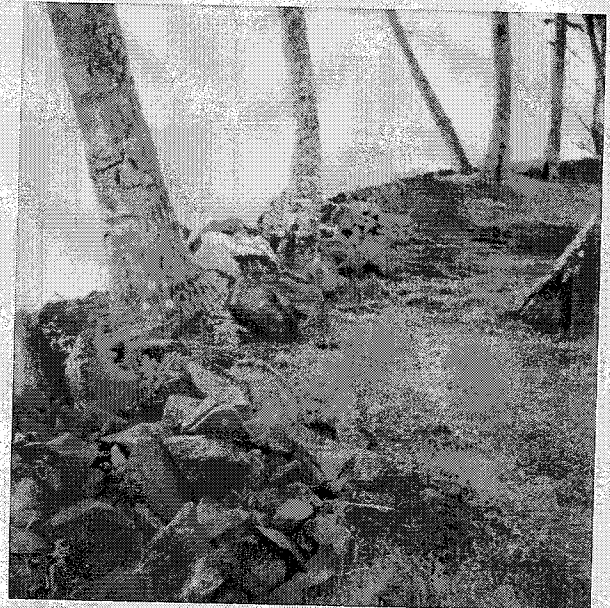
Depicts rocks used in construction
on wall

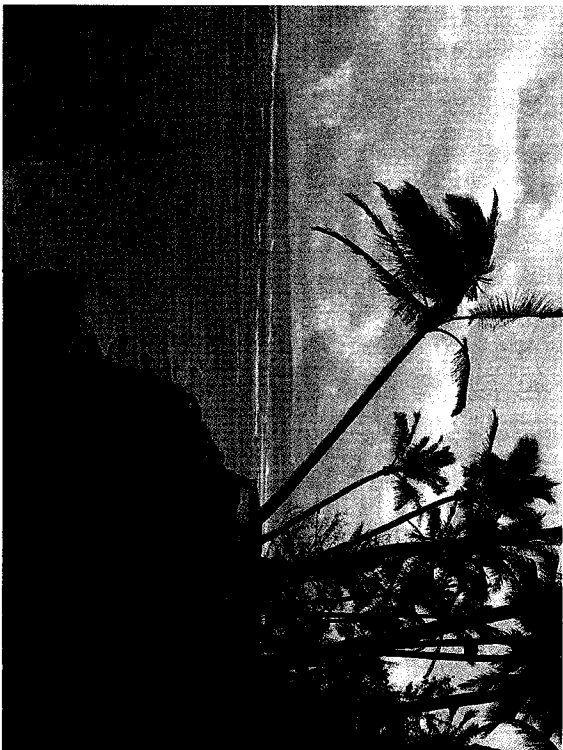
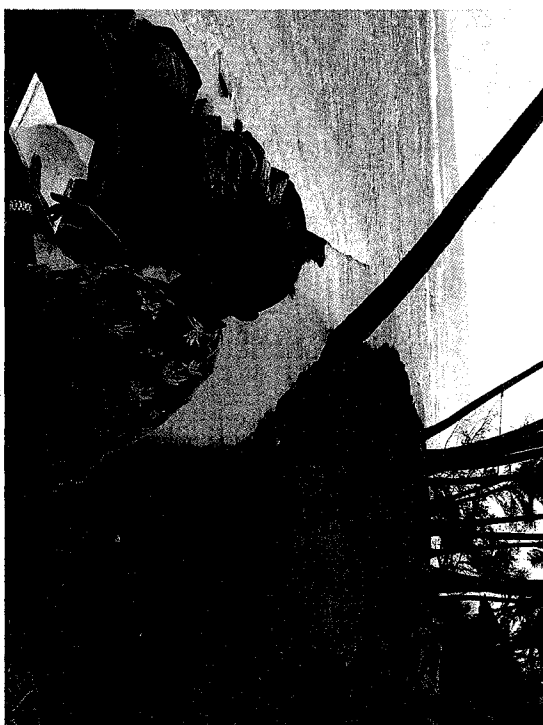
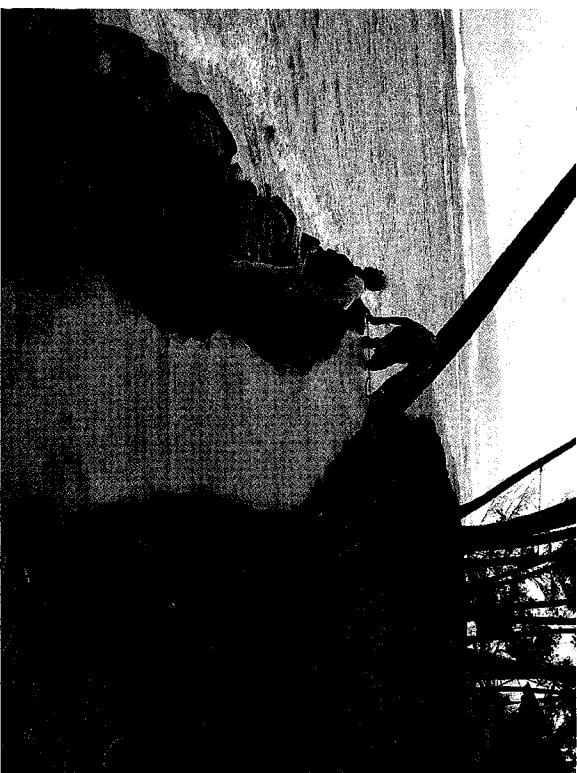
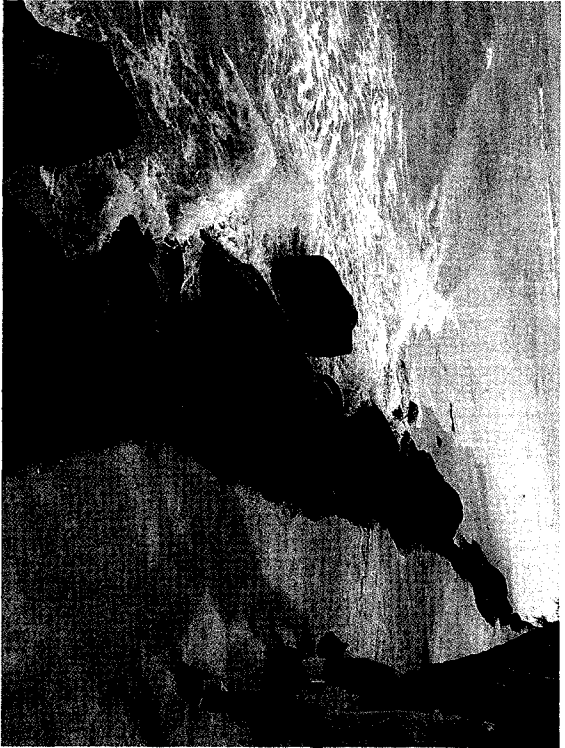
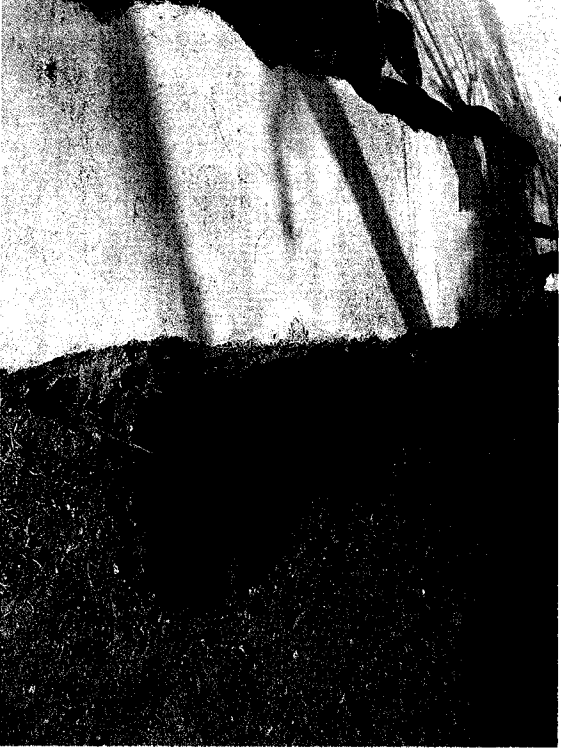
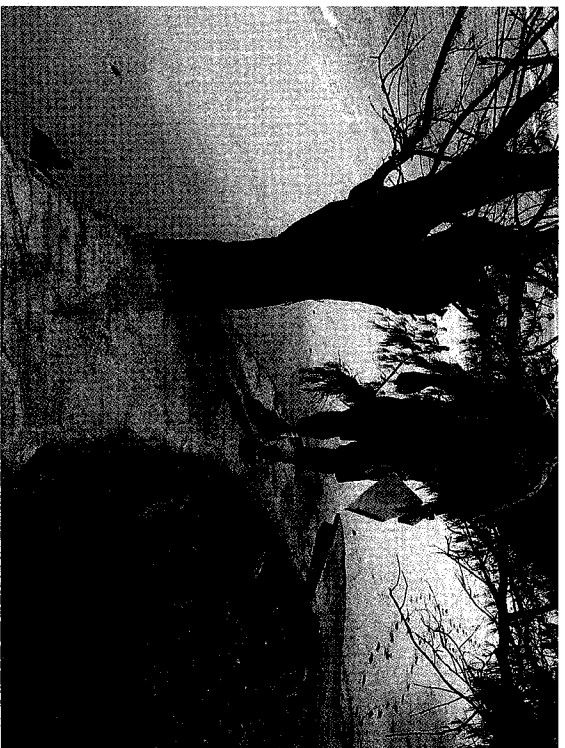
shoreline*. Staff notes that there were unauthorized sand bags littering the beach, sunken areas were developing within the fill material mauka of the unauthorized structure, and large sections of the newly built wall were failing due to scouring and wave overtopping (**Exhibit 14, 15 & 16**).

Staff notes direct evidence (scour, debris and sandbag failure) observed on the February 16, 2007 site inspection clearly illustrate the highest wash of the waves mauka of the structure(s) in question. Because the Department has a "no tolerance" policy in regards to shoreline structures constructed after 1999, the subject actions to substantially repair and rebuild the shoreline structure without authorization fall under this policy.

In addition, the OCCL believes that appropriate engineering considerations were not made during the unauthorized construction/reconstruction of the boulder revetment. Even if repair work to the revetment could be considered, this proposal would still require complete removal of the rocks to build an appropriate filter layer and foundation underneath the top layer of rocks.

4. The landowner shall remove the unauthorized improvements within sixty (60) days of the date of the Board's action;
5. That in the event of failure of the landowner to comply with any order herein, the landowner shall be fined an additional \$2,000.00 per day until the order is complied with; and

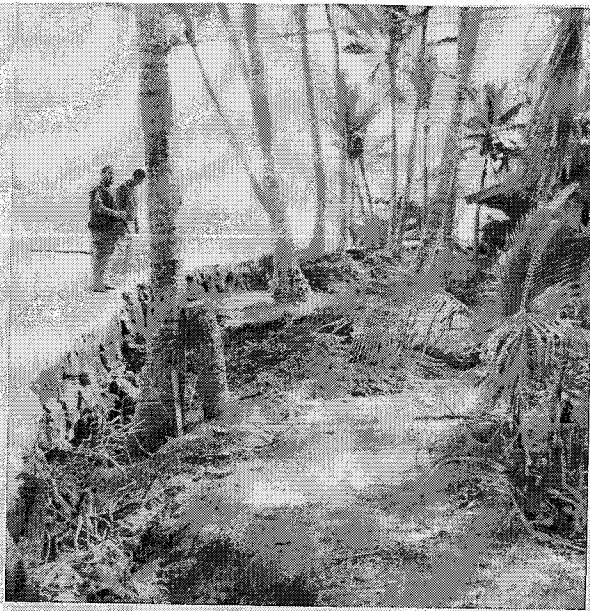
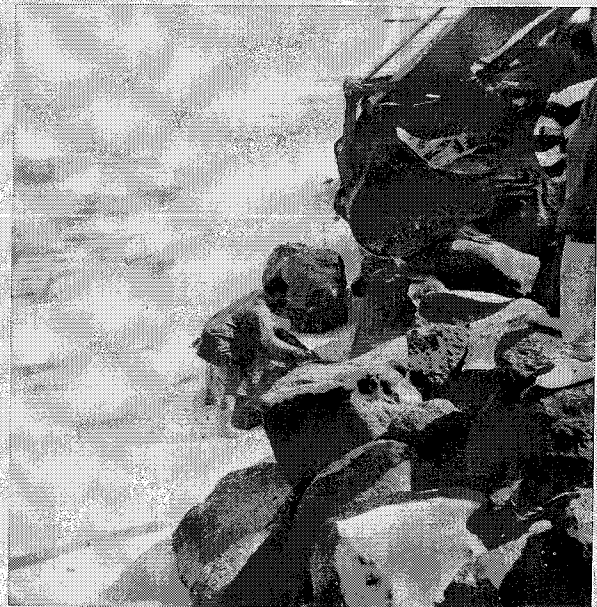
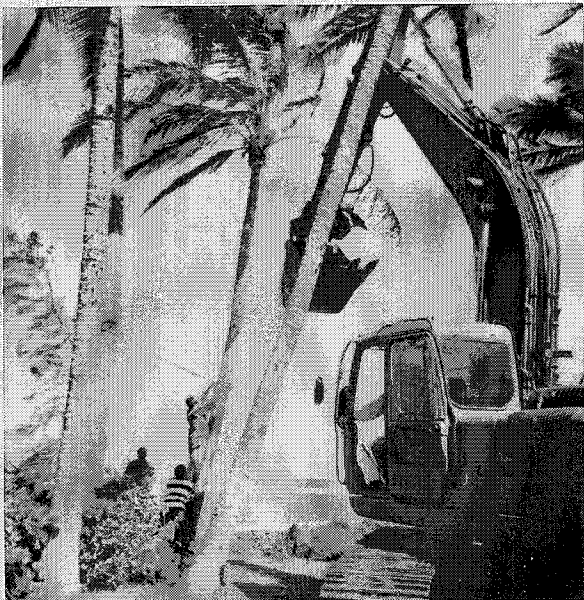
February 21, 2007-Site inspection by a Conservation Enforcement Officer noted work being conducted to stabilize palms along the wall and the retrieval of boulders that had rolled off the wall towards the sea (**Exhibit 17**).
